# **Anthropocene streams and base-level controls from historic dams in the unglaciated mid-Atlantic region, USA**

*Phil. Trans. R. Soc. A* 2011 **369**, 976-1009  
doi: 10.1098/rsta.2010.0335

**Keywords:** Anthropocene; geomorphology; surface processes; base level

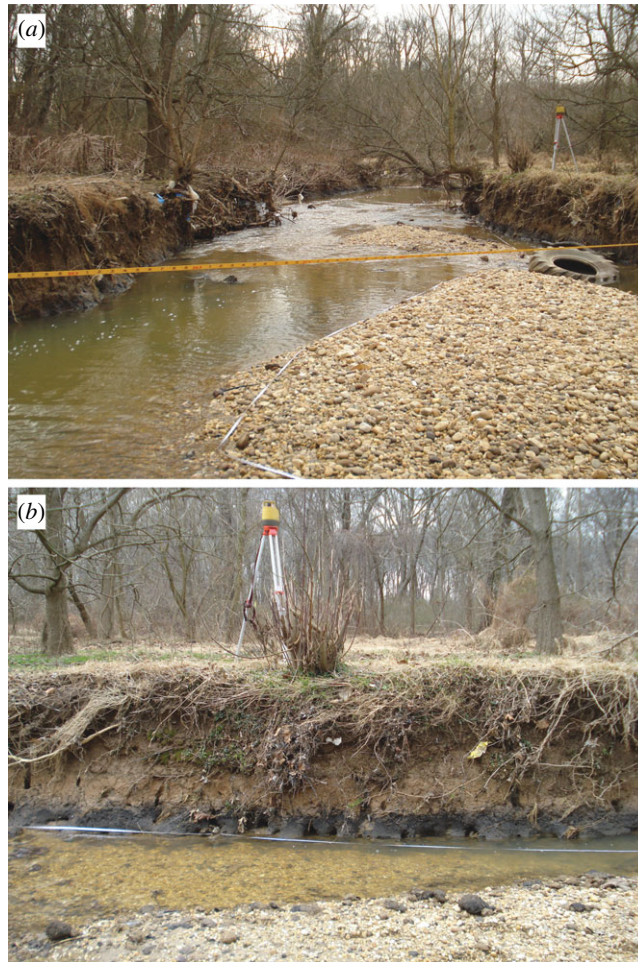
Figure 2. (a) Indian Creek, MD, has the typical characteristics of an anthropogenically formed stream as characterized in this paper. Historic, fine-grained (predominantly silt, clay and sand) sediment overlies a pre-settlement (Holocene), organic-rich, hydric soil (b). Vertical incision, followed by lateral channel migration, exposes high banks to erosion. Confined flows result in high flow depths and shear stresses that, in turn, are capable of transporting gravel as bed load in addition to fine sediment as suspended load. Gravel scoured from beneath the Holocene wetland soil is typically polygenetic in origin, including a quartz-rich denudation lag and various periglacial deposits such as debris fans. Note large cobble-sized clasts of low-density pre-settlement peaty material on the gravel bar. In this case, some of the underlying bedrock consists of Cenozoic conglomerate, which might also be a source of gravel. (Photographs taken by D. Altland and F. Bubczyk.)

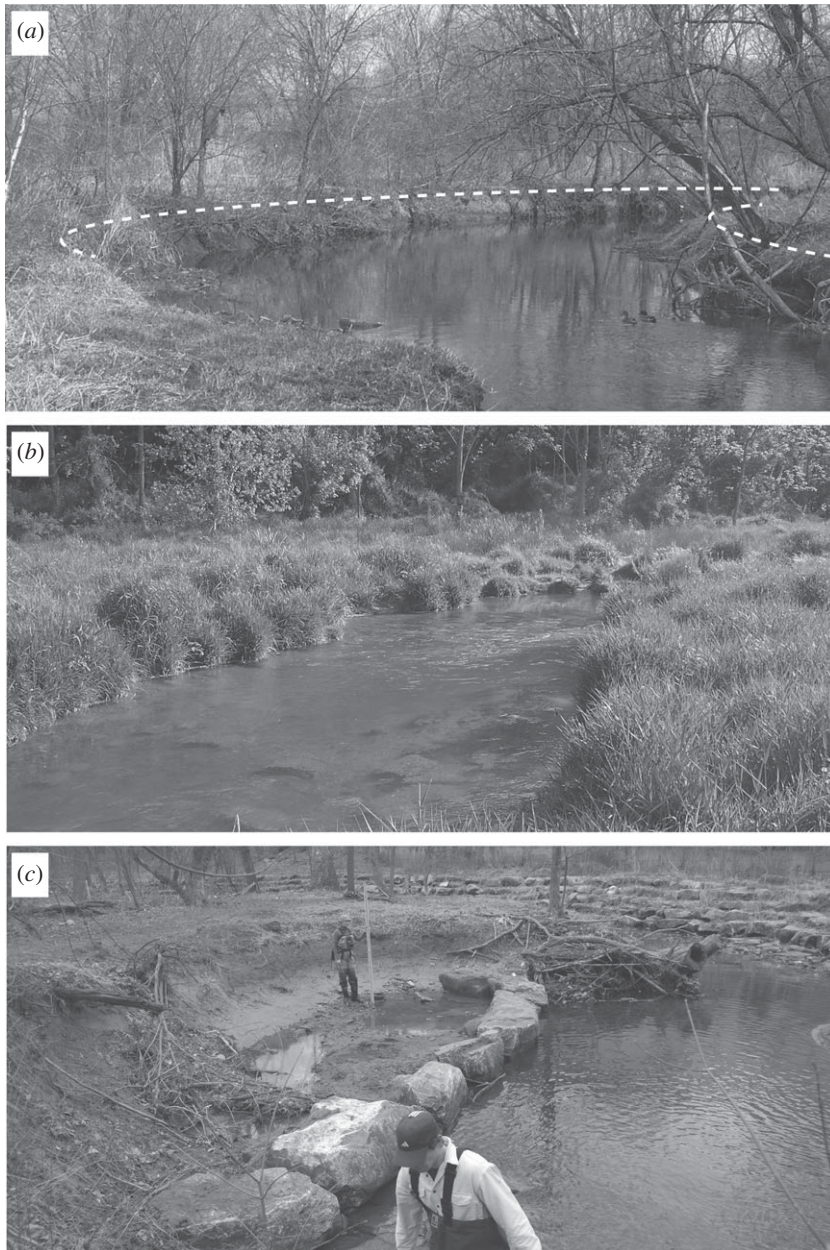
Figure 11. (a) Lititz Run before restoration, in 2001, with high banks of millpond sediment exposed along the incised stream upstream of a breached milldam (photograph by Ward Oberholzer). (b) Lititz Run in 2007, after approximately  $23\,000\text{ m}^3$  of historic sediment was removed to a depth of about 0.5 m above the pre-settlement valley bottom along the stream corridor. Note wetland sedges and other plants that grew in the exhumed wetland conditions soon after restoration. (c) Conventional approaches to stream restoration generally consist of attempts to stabilize meander bends with hard structures, even on incised streams near breached milldams in small headwater areas of streams, as here at Woottens Mill park restoration (completed 2006) along Watts Branch, MD. (Photograph taken March 2008.)

Wetland restoration via removal of historic millpond sediment was implemented in Lititz Creek in southeastern PA, in 2002, and will be implemented at nearby Big Spring Run in 2011. At the site of a breached milldam on Lititz Creek, approximately 1 m of historic sediment was removed from about two-thirds of the original area of the millpond reservoir by an engineering firm, LandStudies, Inc. (figure 11*a*). Within several years, the same obligate wetland

species as those of seeds that are common in the buried hydric palaeosol (various *Carex*, and *Eleocharis*, for example) were growing throughout the restoration reach (figure 11*b*). The ongoing Big Spring Run scientific investigation is designed to fully evaluate the pre- and post-restoration conditions of surface and groundwater, sediment and nutrient loads, and ecological change for a similar approach to restoration.
